3 MOTOR GRADER TEST 3

Caterpillar Grader - Model 12

San Bernardino National Forest

January 23 - March 15, 1950

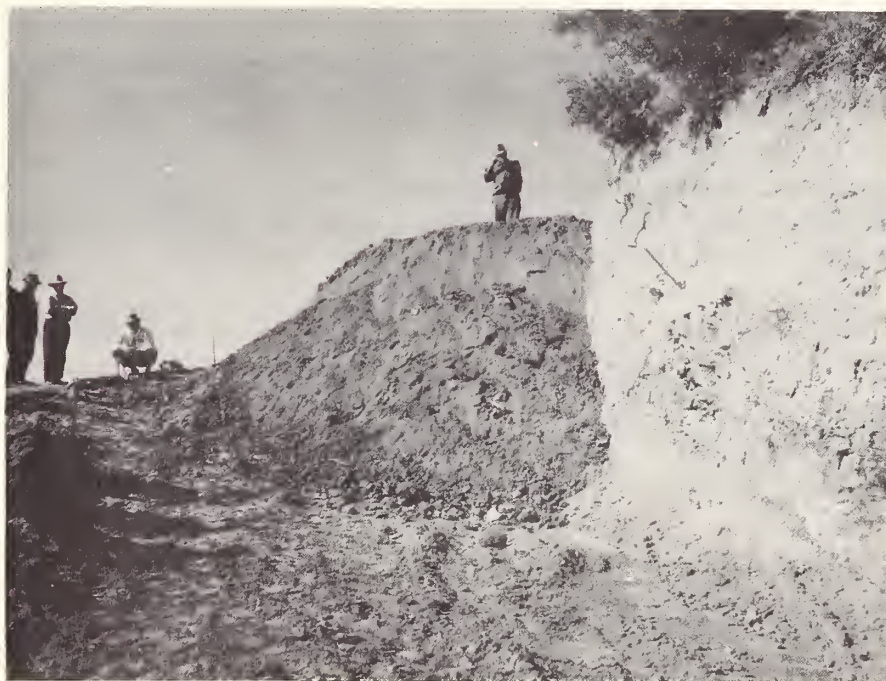
Fig. 4. Test Slide

A slide of designed shape comprising approximately 125 cubic yards was built by a tractor, avoiding compaction of material as much as possible. Dirt was allowed to accumulate on the down-grade (or approach) side at its natural angle of repose, which was approximately 70%. Boundaries were established by means of stakes simulating a perpendicular bank beyond which a wheel under power was not permitted. Refer to Fig. 4.

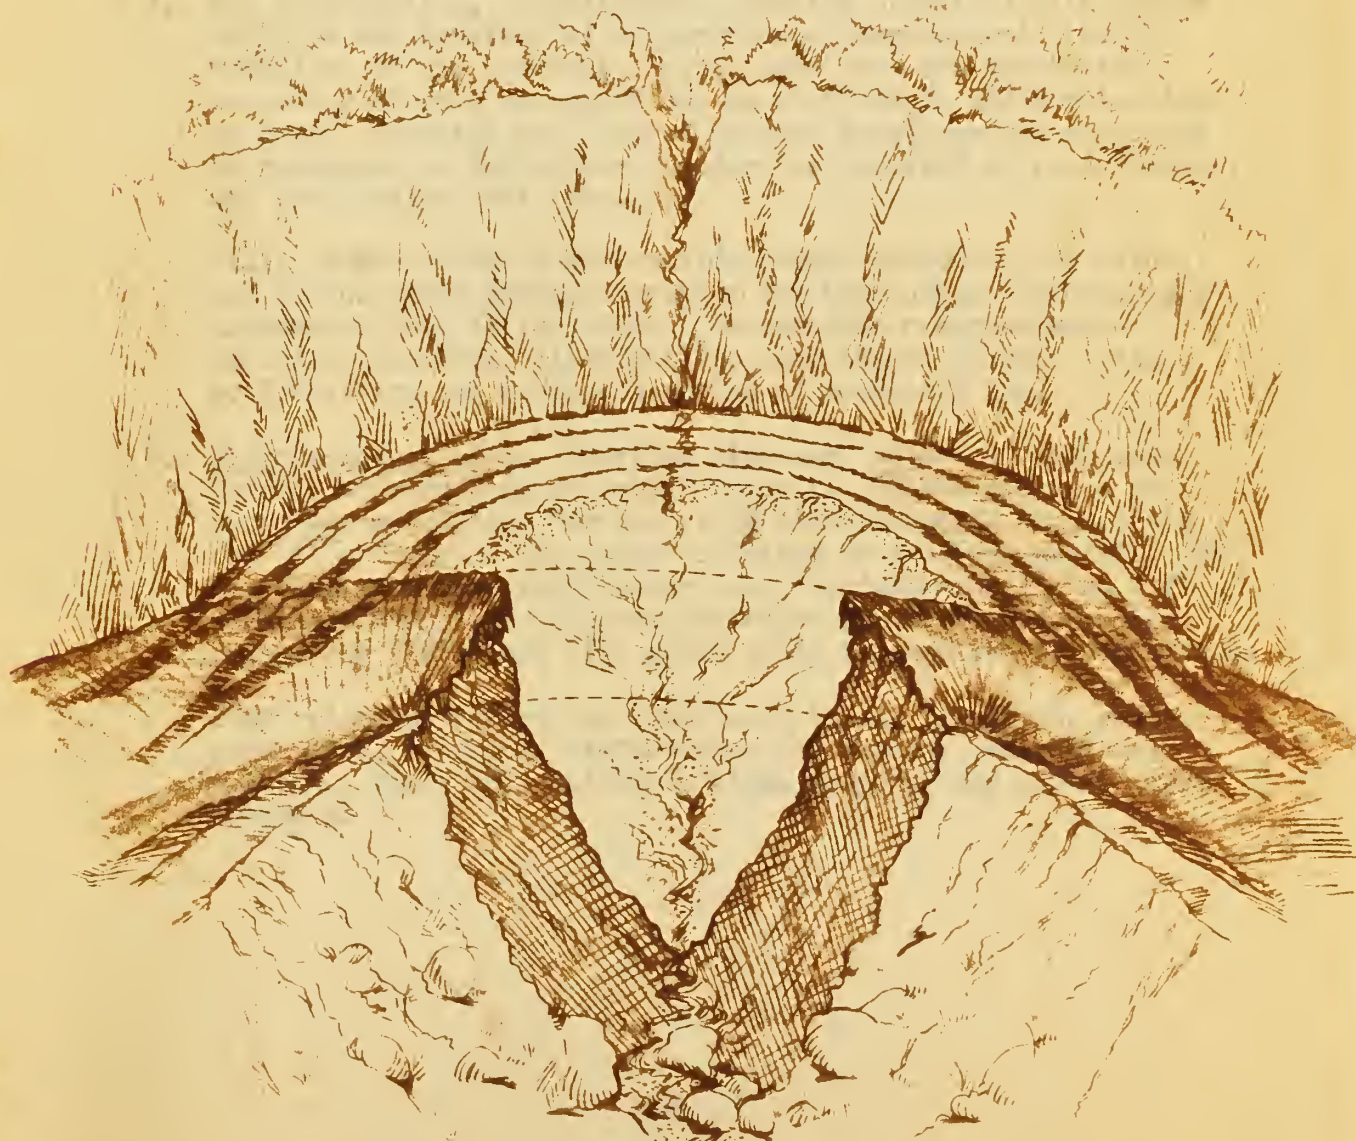
FIG. 5

Conditions of the test: The situation simulated was the wash-out on a canyon crossing, the outer portion of the road being completely gone and the inner portion defined by vertical walls. It was required that the grader was required to travel the curve, using the minimum road width. See Fig. 5 for details and sketch of test layout.

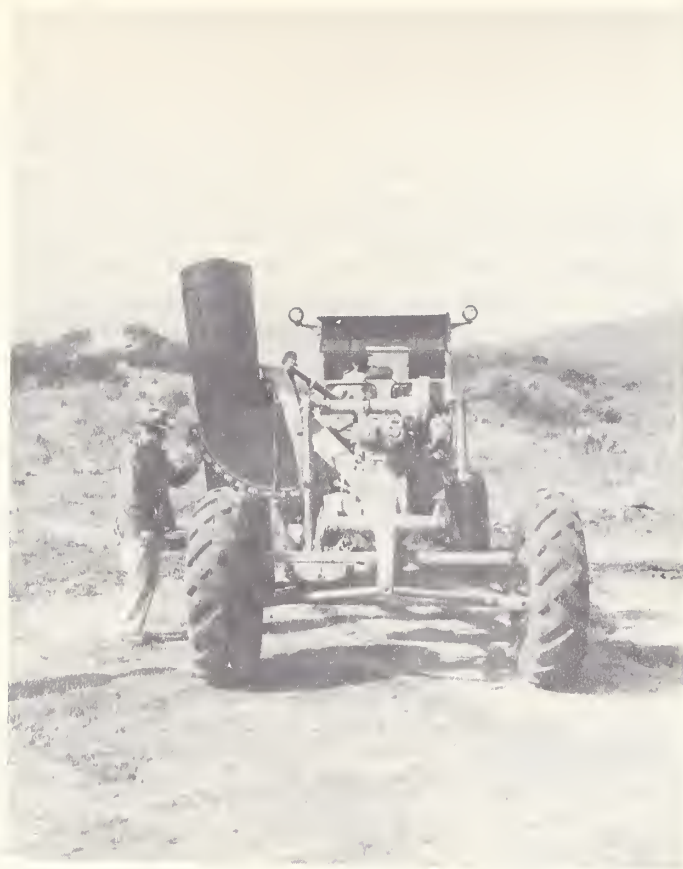
Figure 7. Bank Slope Angle - $\frac{1}{4}:1$

A re-run of test of Bank Slope Blade positions was made with all machines, to obtain more accurate data. In the meantime, a bulldozer attachment had been installed on the Cat #12 and it was decided to attempt to attain test slop angles with this attachment intact. A maximum of only 63° was attainable. Interference between the circle drawbar, scarifier linkage, and bulldozer attaching frame prevented the attainment of over 63° . Previous bank slope tests of the Cat #12, without bulldozer attachment, proved the 76° angle could be attained without difficulty. Refer to photographs, Figures 7 and 8.

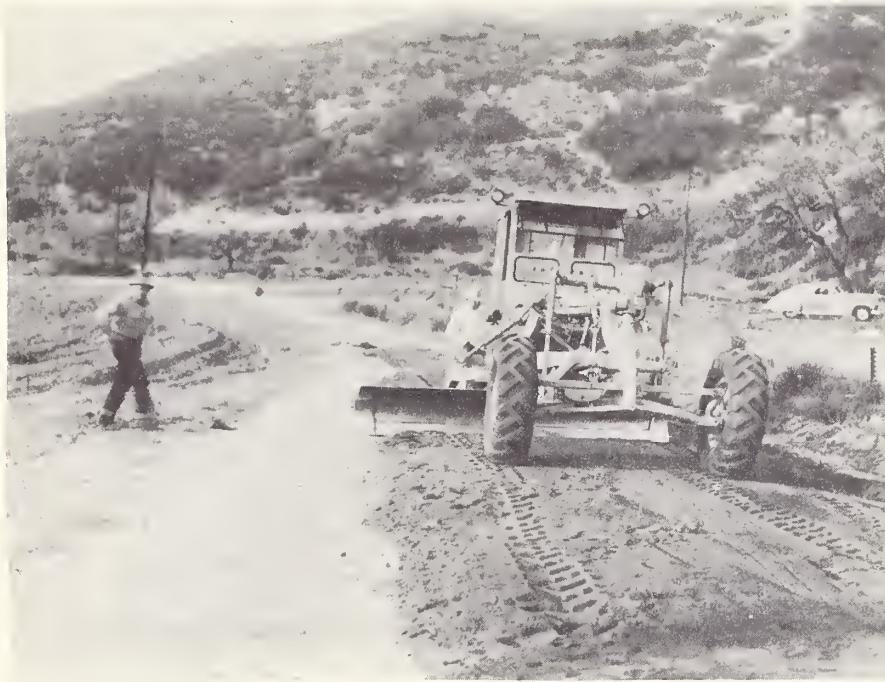
Figure 9. Blade Side Shift

The time required to offset the Cat #12 blade on the circle was not obtained with accuracy. Difficulty was encountered in the first attempt due to a binding condition. This was conceded to be caused by heavy paint on the blade shift sliding surfaces, as shifting was accomplished more freely after paint was removed. However, due to the tendency to bind, and uncertainty of positive lock position, this particular method as used on the Cat #12 was considered by test observers to be less desirable than the power ram or unbolt-rebolt methods used on other units. Photograph, Figure 9, shows blade side shifted on circle.

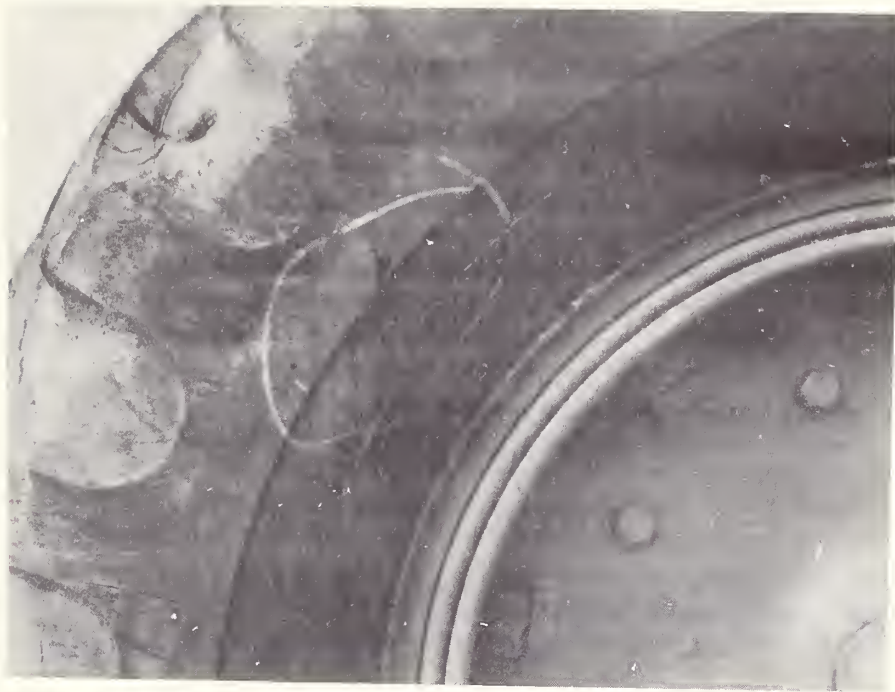
Figure 13. R.R. Tandem Side Wall Cut

Tires on the Cat #12 were Firestone 13:00x24 - 12 ply, and rated with the heaviest in the 13.00 size. Inspection upon completion of the test showed wear on tires to be negligible and only one small sidewall cut on right rear tandem was found.

Cat #12: Wear - "Negligible", Breaks - "None" (one small cut, sidewall, R.R. tandem.)

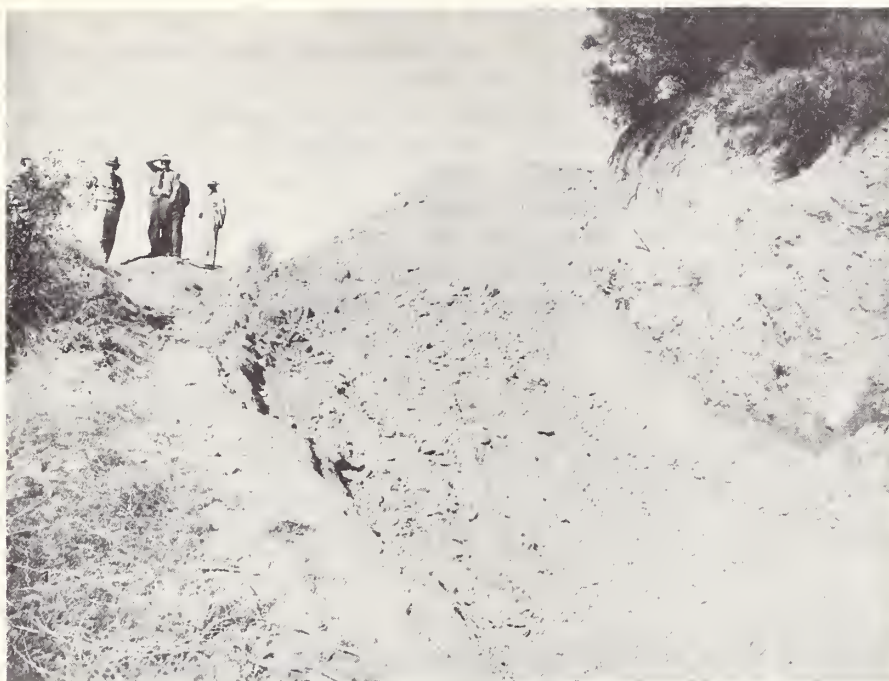
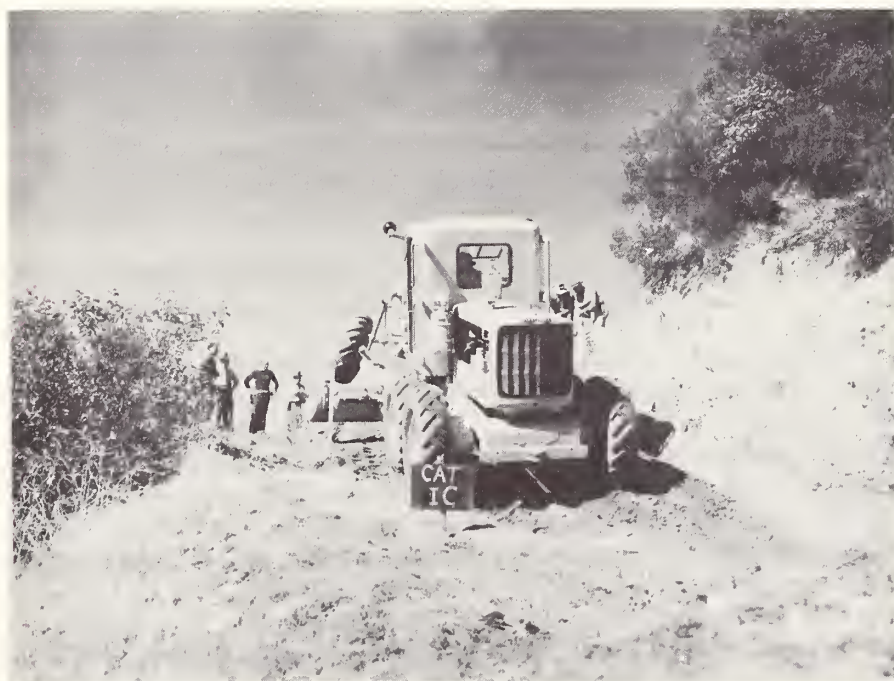
Figures 16 and 17 show the slide before and while being worked on by the Cat #12.

Figure 16. Slide - Before Test

Figure 17. Slide - During Test

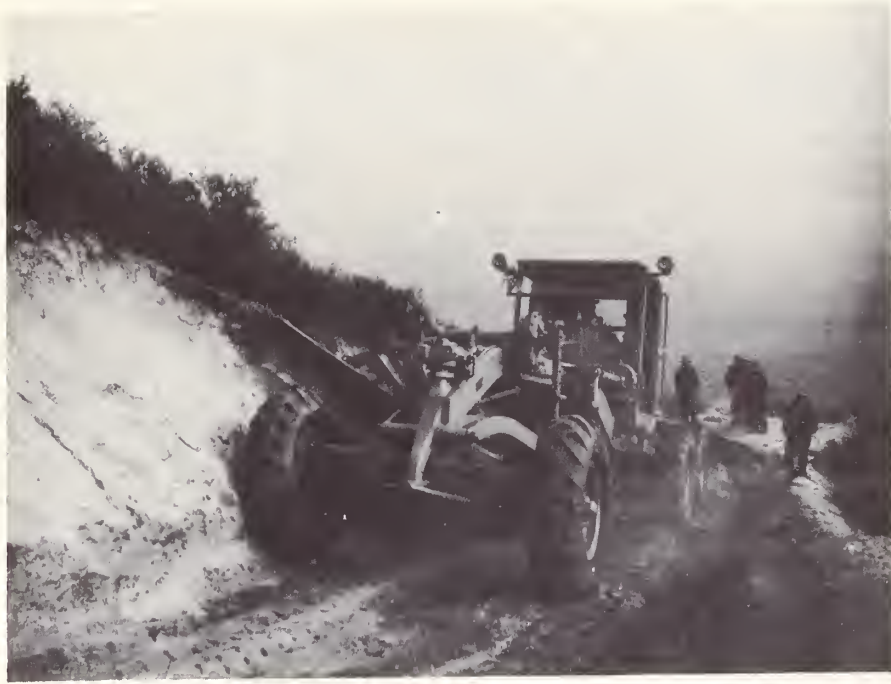
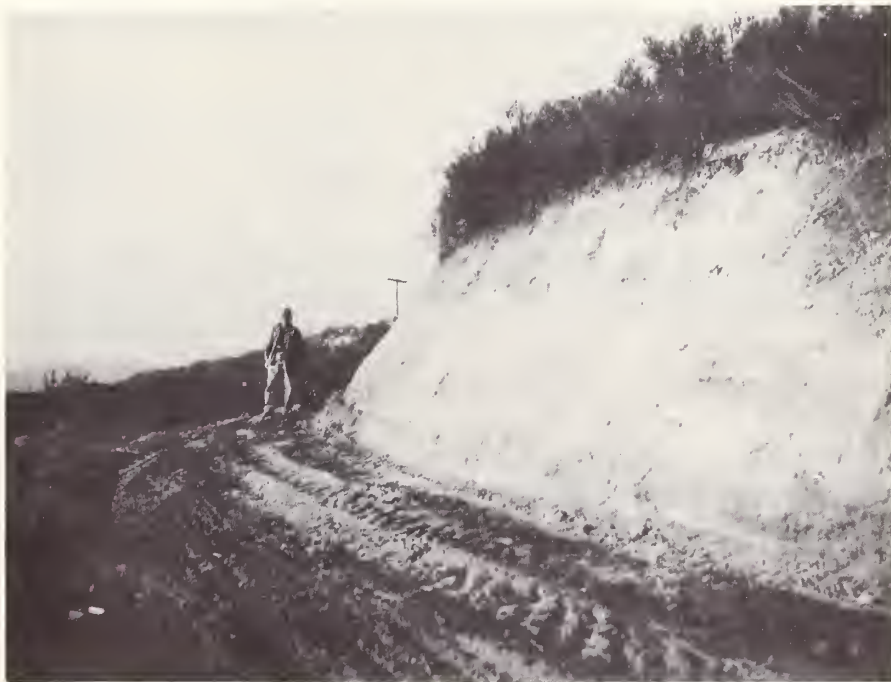
It was conceded by test observers that all tandem graders would have some difficulty in bank sloping short radius inside curves. On outside curves and tangents this difficulty was not apparent. Refer to photograph, Figures 20 and 21.

Figure 20. Bank Sloping

Figure 21. Bank Sloping - Outside curve.

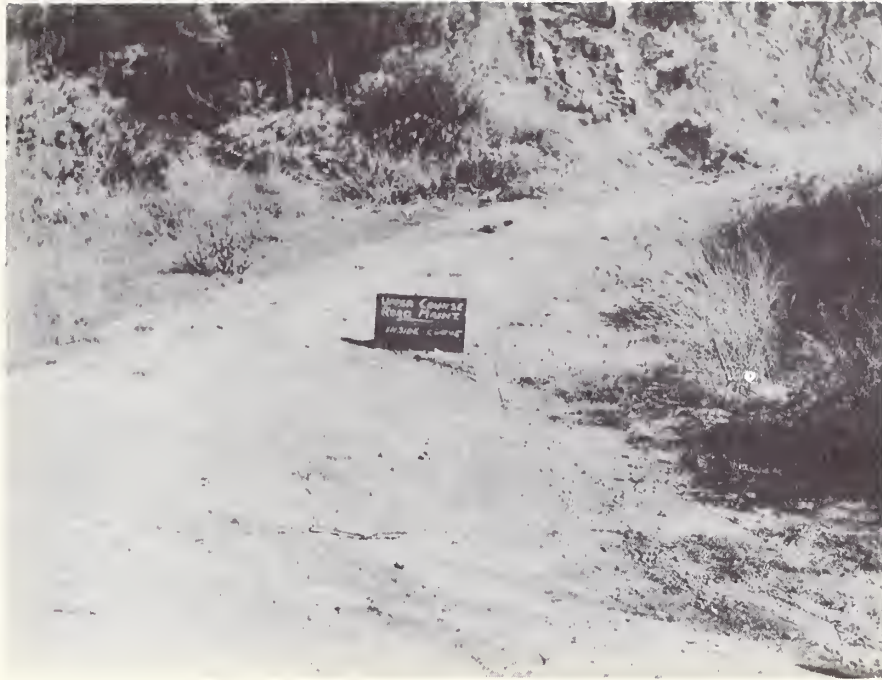
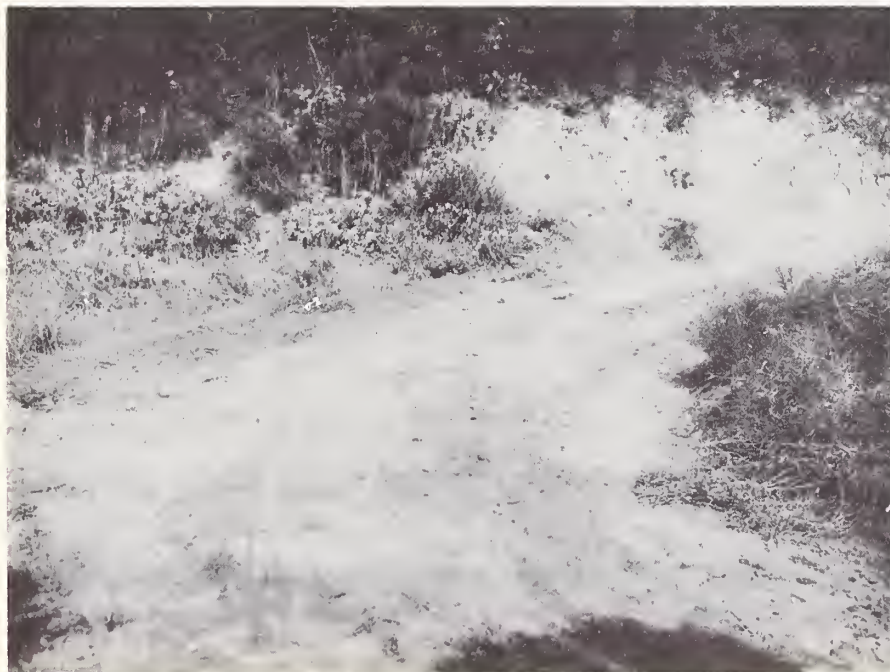
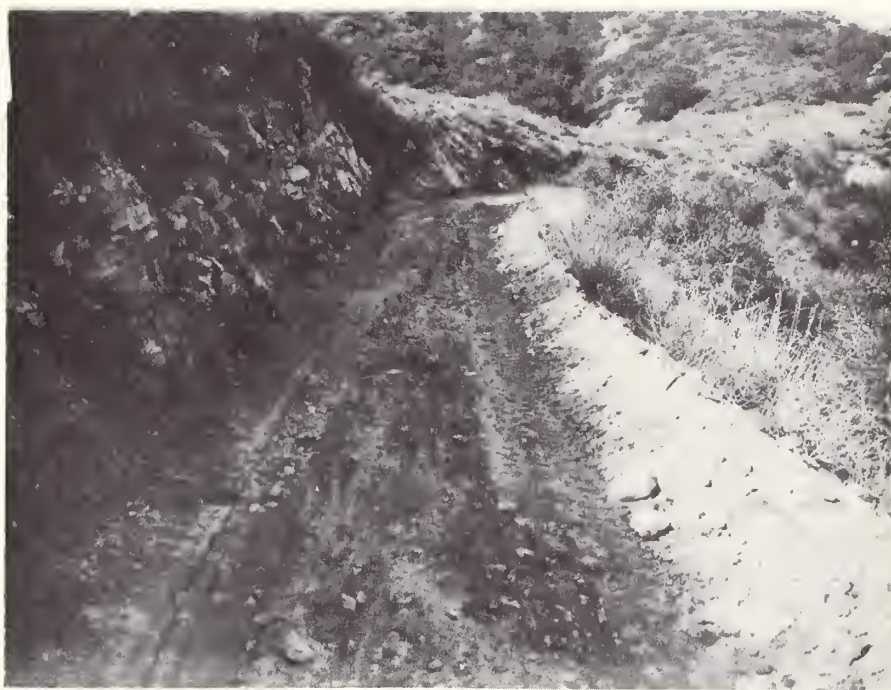
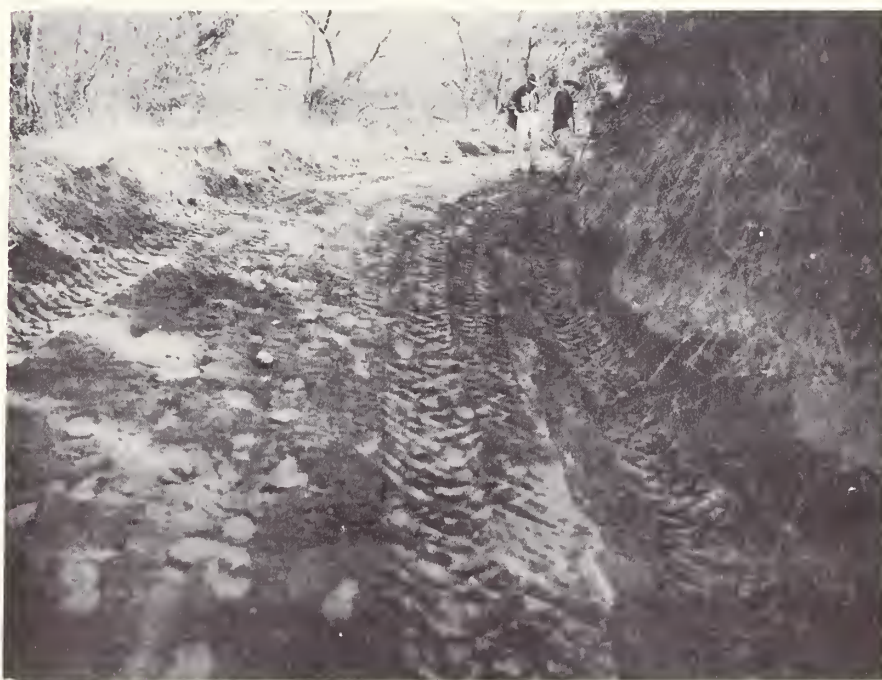
Many photographs were taken of the test in an effort to record the operation. These were studied during preparation of the report. Four which were considered pertinent are shown as Figures 22 to 25.

Figure 22. Typical Section Prior to Grading.

Figure 23. Same Section after Road Grading.

Figure 24. Completed Section of Road Grading

Figure 25. Completed Section of Road Grading.

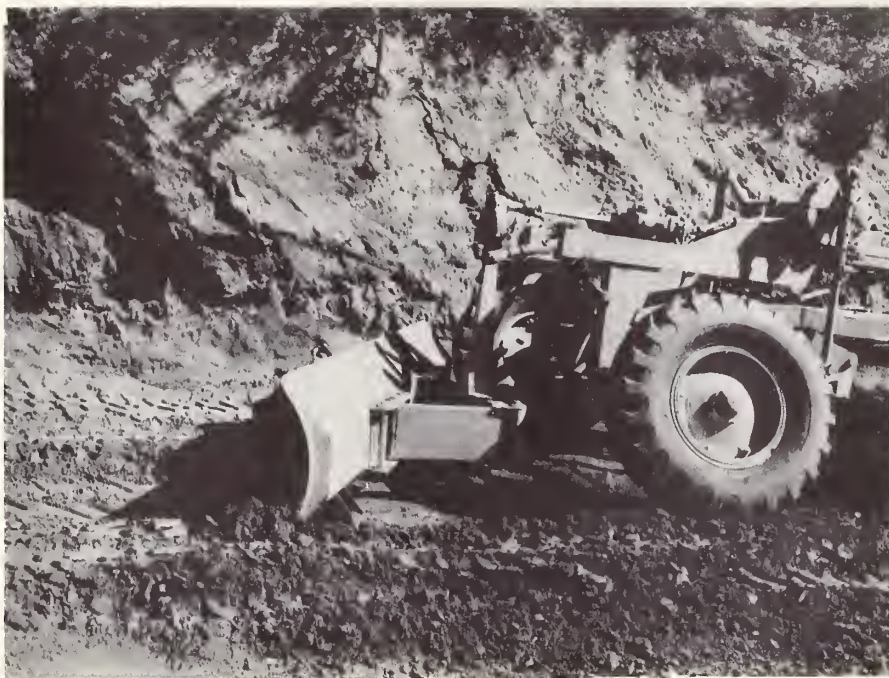
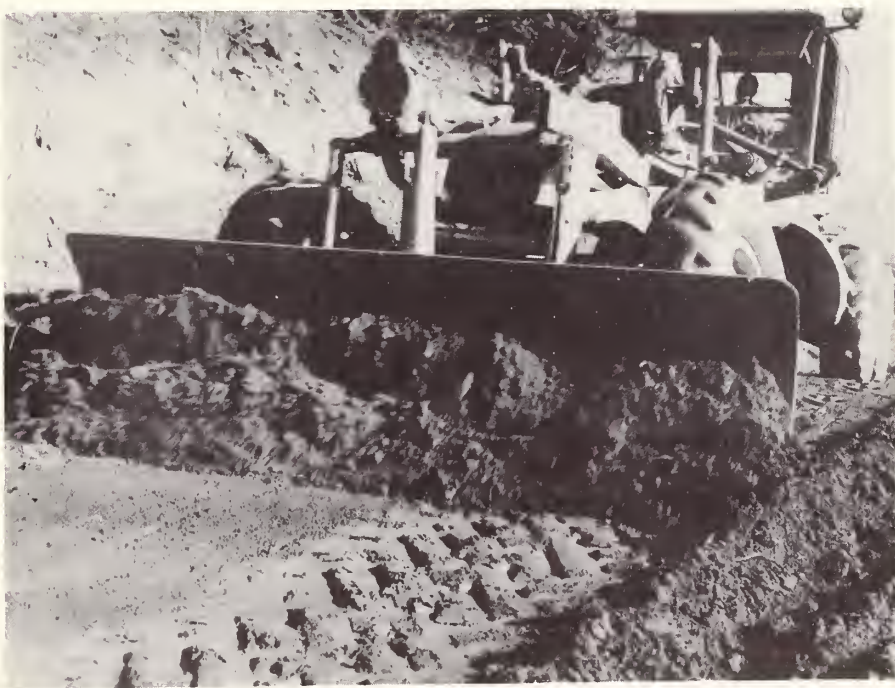
The Cat #12 dozer and attaching assembly is comprised of extensive frame work, shafts, gear box, linkage, shaft pins, etc. which was the cause of the longer installation time. The other dozer unit was installed by simple attachment at three points. However, once installed blades only could be removed or replaced in comparable time. Photographs Figures 26 and 27 show Cat Dozer Blade installation.

Figure 26. Caterpillar Dozer Attachment.

Figure 27. Dozer in Operation.
